# Manhole Inspection Summary

Manhole # S07QQ1023MH

Insp Date: **7/9/08 8:47 AM**

**Location** Address: **5272 PARK HEIGHTS AVE** Cross Street: **HAYWARD AVE**

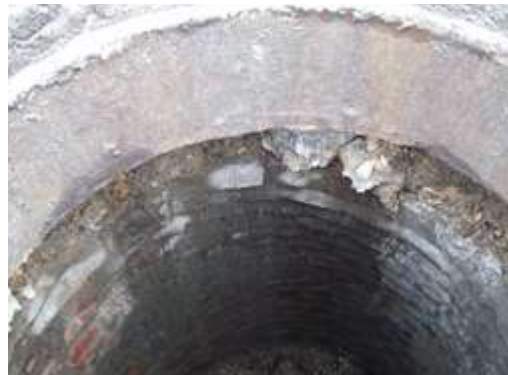
Defect 3

Condition: ☐ Sound ☒ **Cracked** ☐ Root Intrusion ☒ **Loose Brick** ☒ **Deteriorated**

LOOSE BRICKS, DETERIORATION OF CHIMNEY

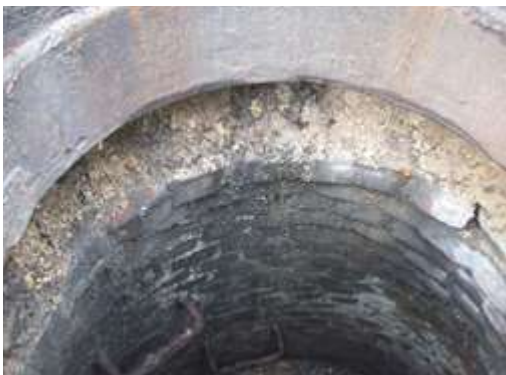
Defect 1

INFILTRATION OF CORBEL WALL

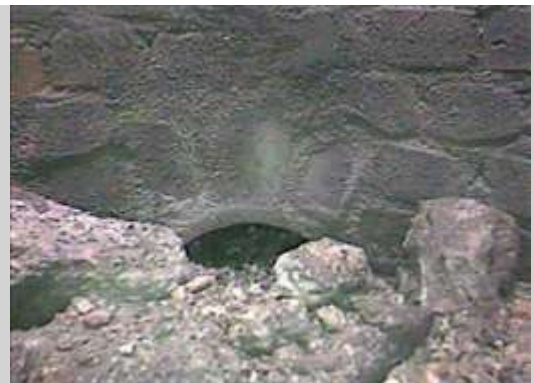
12 O'Clock Outflow

8 in. Circular Gravity Sewer  
Pipe Out @ 12 O'Clock

Deposits: ☐ None ☐ Mud ☐ Sludge ☒ **Debris** ☐ Grease

Silt Depth: **8** (in.) Deposits Extent: **Heavy**
